VersaMax® Nano PLC and Micro PLC CPUs

GFK-2566A

Important Product Information

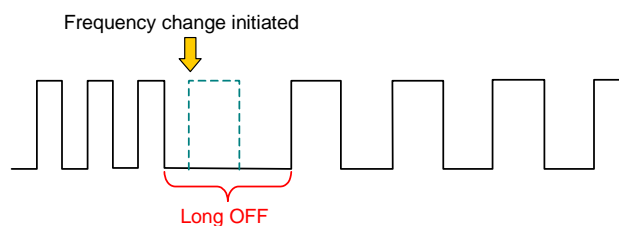
Long OFF:

- **Output Waveform During PWM Frequency Change:** During PWM frequency change, a Long OFF or Long ON may occur at the first pulse of the new frequency. Examples are illustrated below.

If the transition occurs while the pulse is OFF, the maximum time the output is OFF is equal to the old frequency OFF state duration plus the new frequency pulse duration.

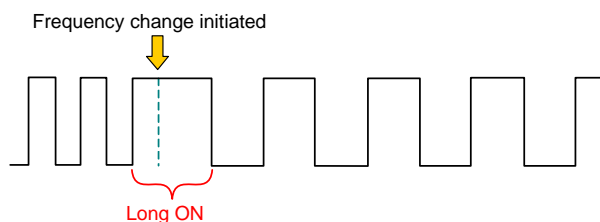
Long ON:

If the transition occurs while the pulse is ON, the maximum time for which the output is ON is equal to the old frequency ON state duration plus the new frequency pulse duration. (Micro 20/40/64)
